# Peacock Labs Mirror Coating Testing and Analysis

M. D. Holenstein

Gravic, Inc.

August 18, 2010

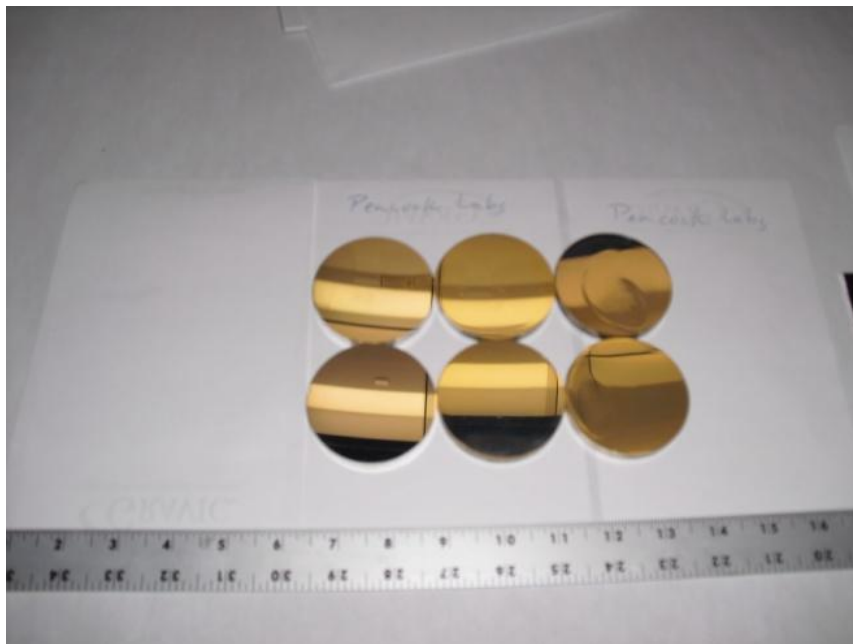
*Figure – six mirrors were returned by Peacock Labs. All were coated with their silver solution. The two on the left were silvered, but uncoated. The middle two had a thin Permalac overcoat, and the two on the right had a thick overcoat.*

2 thick Permalac coatings- Very yellow in color, when held up to the light they appear semi transparent to the degree that 10-15% of light is transmitted. The thick overcoat seems to have runs or finger print type indentations.

2 thin Permalac coatings- The surfaces are mostly uniform with a yellow tinge color. The coating seems to have run slightly during the drying process.

2 uncoated- The brightest mirrors and appear to be the best of the test group. The color is slightly more silver than the others with Permalac coatings. One of the uncoated mirrors has a surface abrasion which may affect the testing of the mirror.

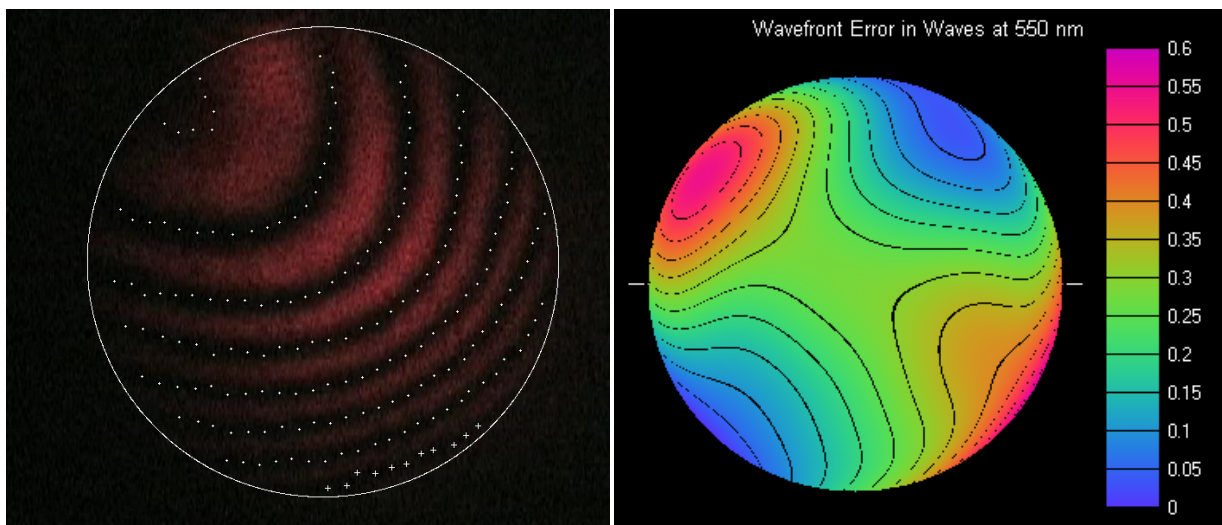
Mirror #2 before silvering. Note that the interferogram fringes are faint because the mirrors were uncoated.

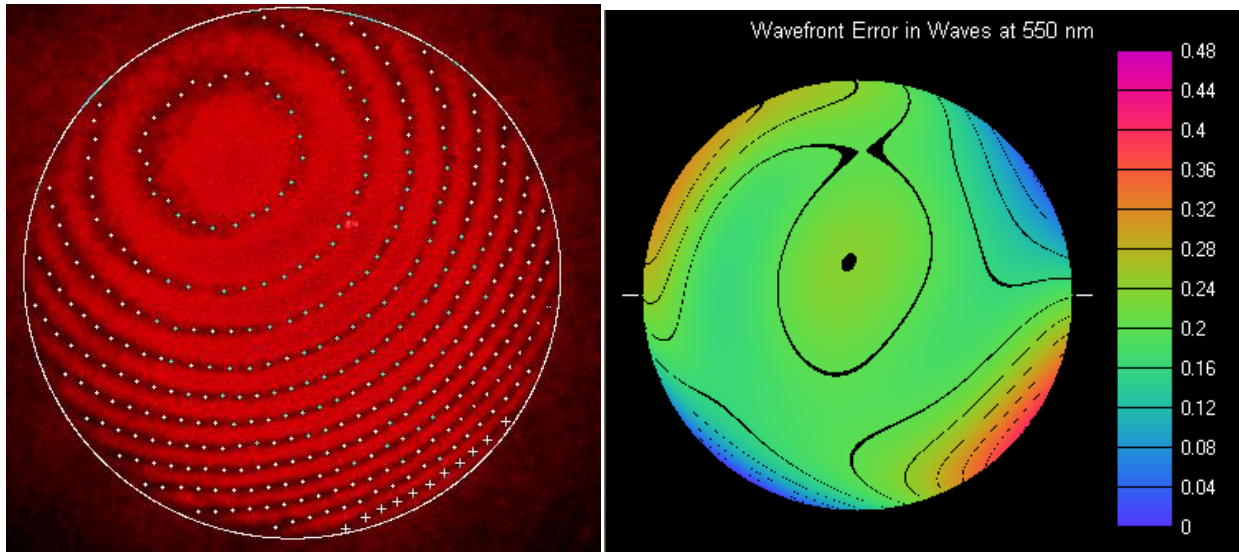
With silvering

The surprising result is that the Strehl Ratio increased for the silvered, but not Permalac overcoated mirrors (#'s 2 and 4)!

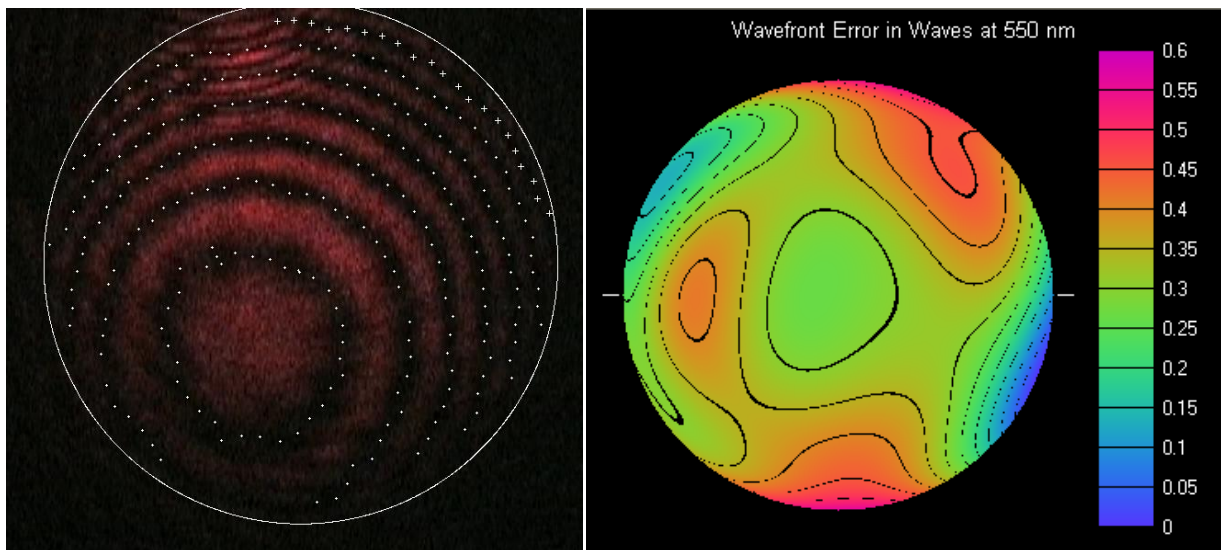
### Mirror #1 thick Permalac

The interferogram for this mirror after overcoat was indistinguishable (no fringes) due to large surface aberrations.

It appears that the thick coat ran quite a bit before the Permalac dried and cause indistinguishable interferograms (no fringes). The surface of one may have been touched before it was dry. The indentations look like a thumb print from someone not handling the mirror properly soon after coating.

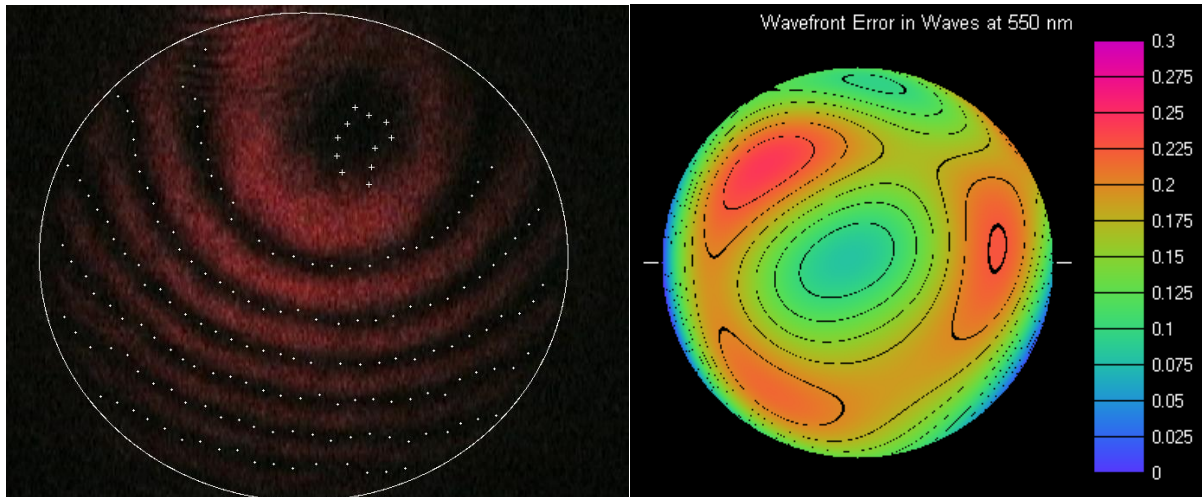
### Mirror #3 thick Permalac

The interferogram for this mirror after overcoat was indistinguishable due to large surface aberrations.
