Lander University Flats and 11” Spin-Cast Epoxy Mirror Tests – No. 2

Bruce Holenstein and Dylan Holenstein/Gravic

November 16, 2011

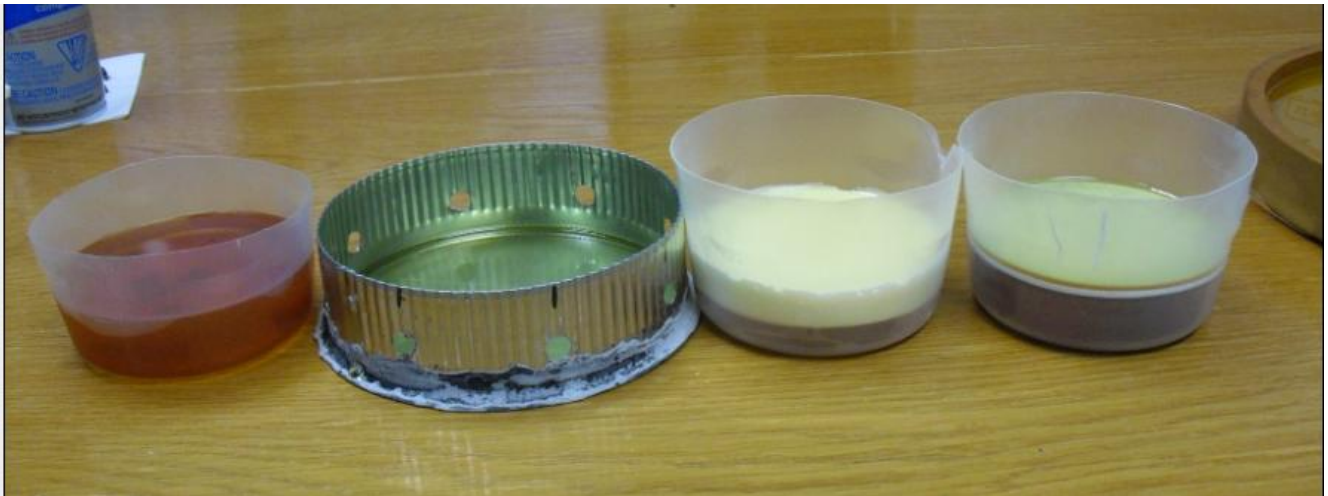
Figure 1. From left to right BLB-31.1 to BLB-31.4 Lander epoxy-substrate flats.

Table 1 - Lander Flats				
Flat No.	Composition	Diameter (in)	Weight w/container (oz)	Notes
BLB-31.1	2-layer: epoxy, thin epoxy	4.5	11	Smooth, small ridge on surface
BLB-31.2	1-layer: thin epoxy, metal cell	6	8	Smooth
BLB-31.3	2-layer: epoxy, epoxy w/microspheres	4.5	8	Small ripples
BLB-31.4	3-layer: epoxy, thin silicone rubber, thin epoxy	4.5	13	Small ripples, fingerprint

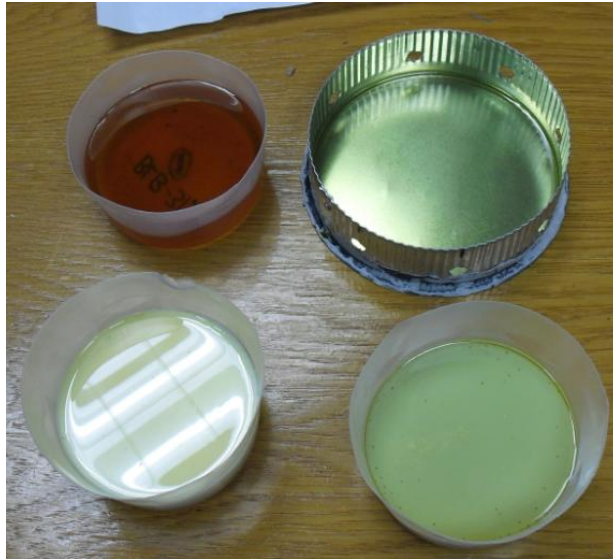
Figure 2. Lander flats from above. To the eye the flats appear flat and the surfaces mostly defect-free.

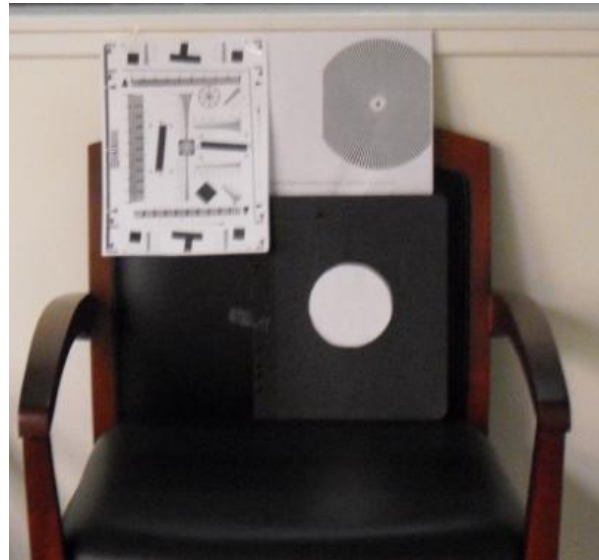
Figure 6. The white test spot is 4.5 inches in diameter so it subtends 1031 arc seconds at the flat under test (17.2 arc minutes).

We decided to test a 60 mm diameter region of the flats by reflecting an image of a distant test target into a small Meade refractor. The test target was at a distance of 75 feet. The flat was set to 45 degrees so the angle of incidence and reflection off the flat surface were 22.5 degrees. Figures 5 to 8 show the experimental setup.

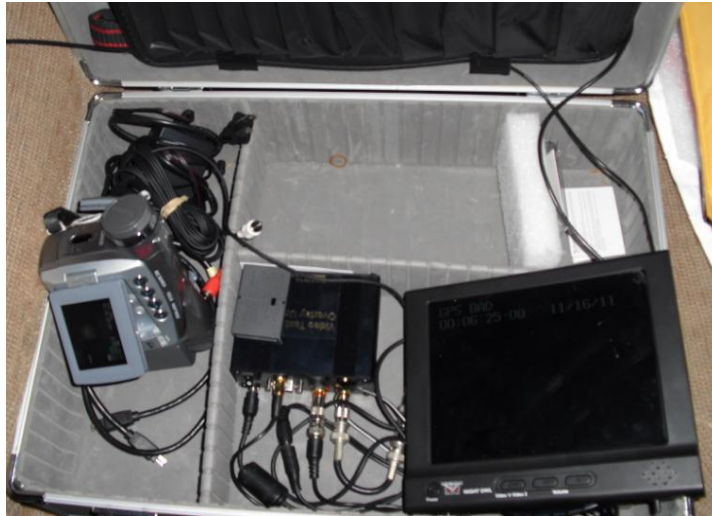
Figure 7. Video recording equipment. The Canon DVR, GPS time insertion device, and monitor are seen.

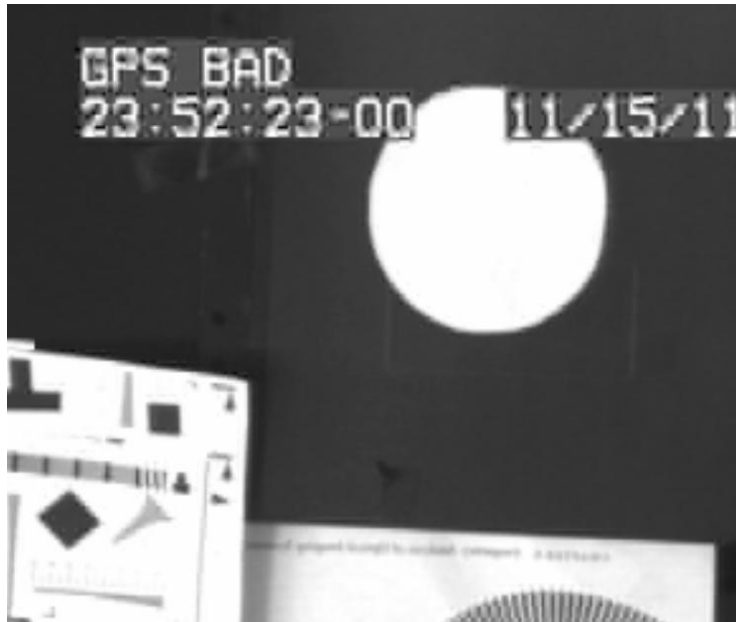
Figure 8. Image of the test target with no flat in use (aimed directly at the target).

The reflected light off of the flats was low in most cases resulting in images which are darker and have more read noise than the Figure 8 image. Some characteristic frames follow.

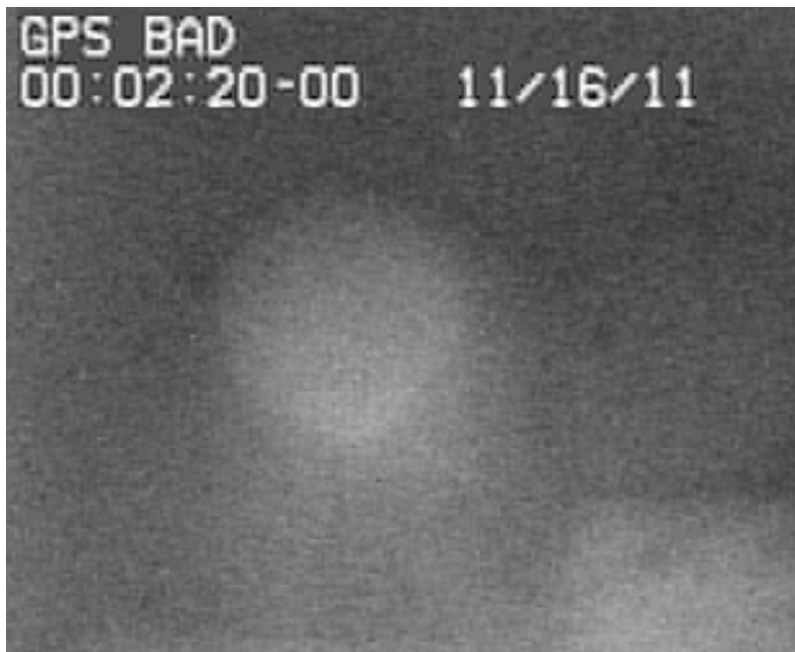
Figure 9. Image from light reflected off a 60 mm diameter region of the BLB-31.1 flat. Aberrations limit the resolution of the image to a couple of arc minutes.

The reflectance tests show that the BLB-31.2 flat, with its single thin epoxy layer on a metal surface, has a superior surface to the other flats. The other flats show local regions which are flat, but not to the degree seen overall with BLB-31.2.

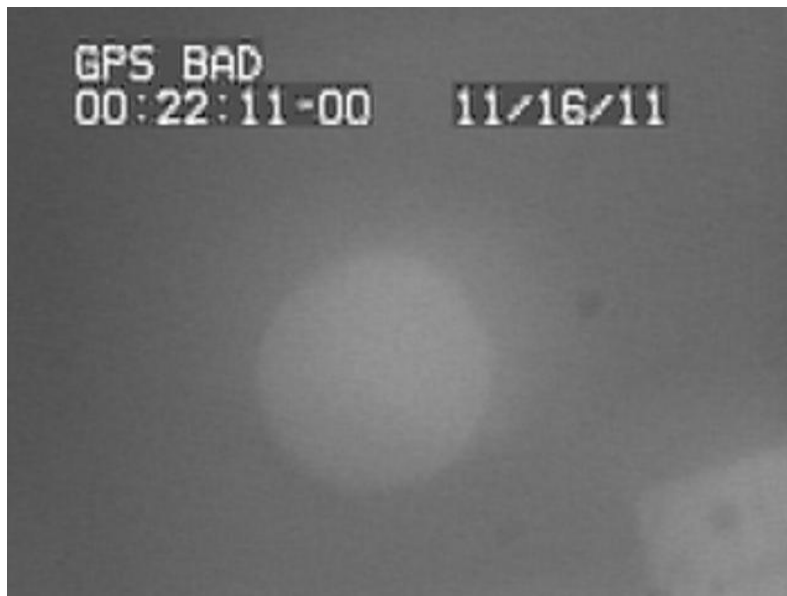
Figure 10. Image from light reflected off a 60 mm diameter region of the BLB-31.2 flat. Aberrations limit the resolution of the image to about 20 to 30 arc seconds.

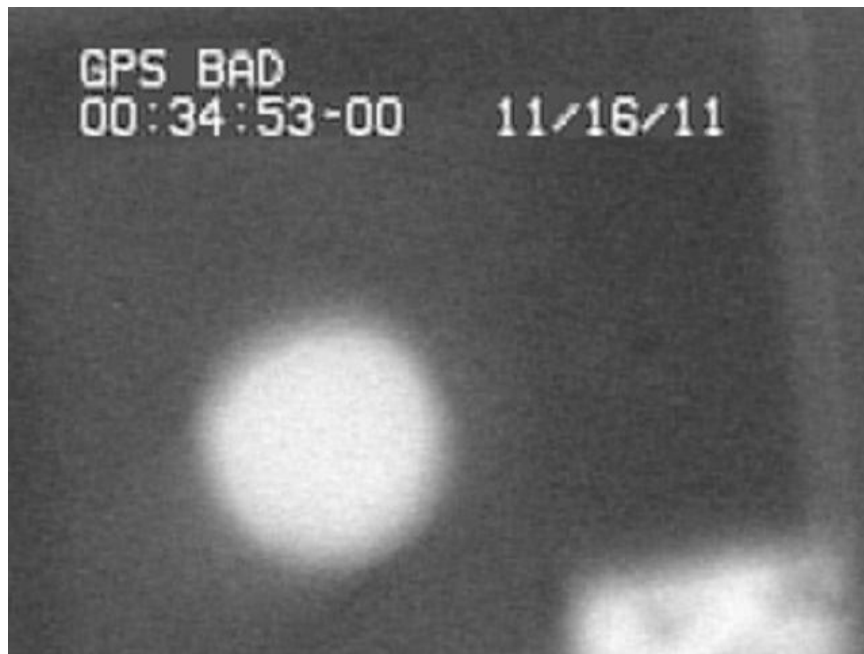
Figure 11. Image from light reflected off a 60 mm diameter region of the BLB-31.3 flat. Overall reflectivity of this flat was much higher. Aberrations limit the resolution of the image to about one arc minute.

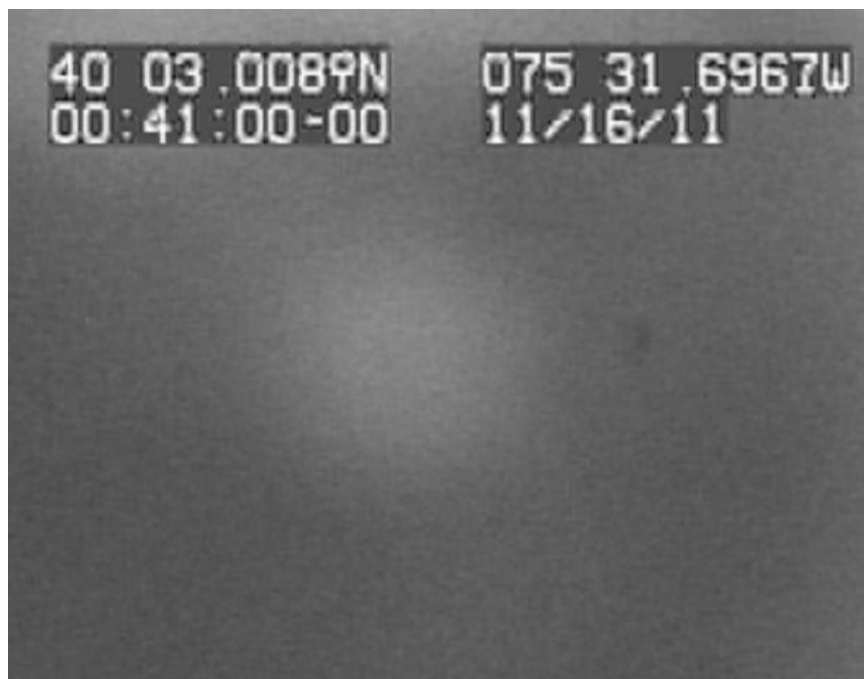
Figure 12. Image from light reflected off a 60 mm diameter region of the BLB-31.4 flat. Aberrations limit the resolution of the image to about 5 arc minutes or worse.

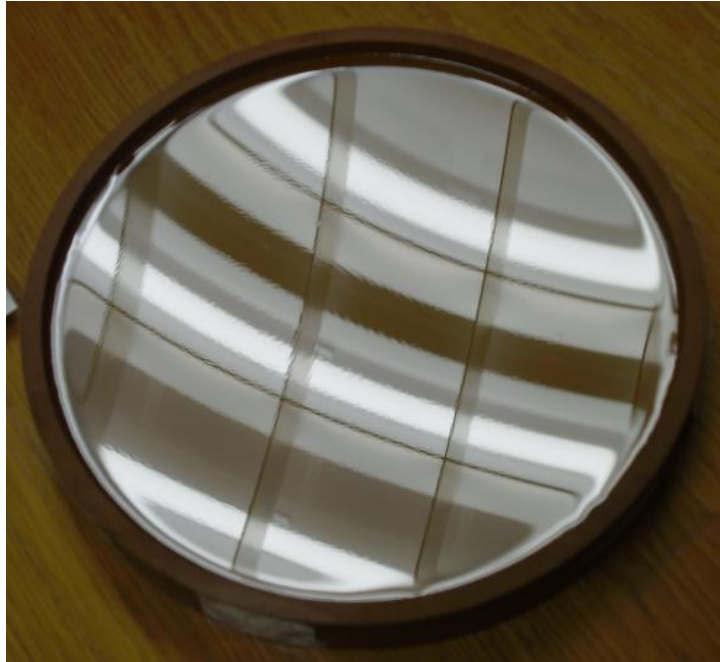
Figure 13. Lander KLB-161 11" spin-cast epoxy mirror as delivered.

We ran a few tests on an additional Lander 11" spin cast epoxy mirror numbered KLB-161. Like the first 11" Lander mirror (KLB-157) we tested, this mirror was fabricated in a CNC'ed foam shell. Up close, the mirror shows a thin raised edge of about a millimeter width due to surface tension during the epoxy fabrication process. No fingerprints are visible on the surface.

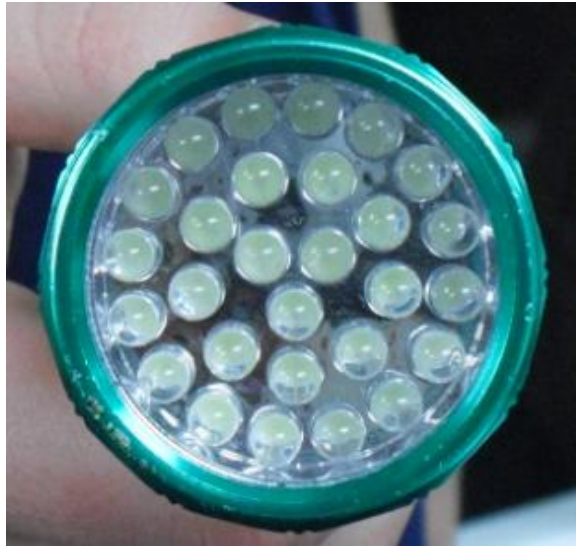
Figure 15. 1.75" diameter LED flashlight source for spin-cast mirror test.

To test this mirror we set up a 1.75" diameter flashlight with 28 LEDs at a distance of 182". The focus appeared at about 31" indicating a mirror focal length of about 26" and a speed of $f/2.4$.

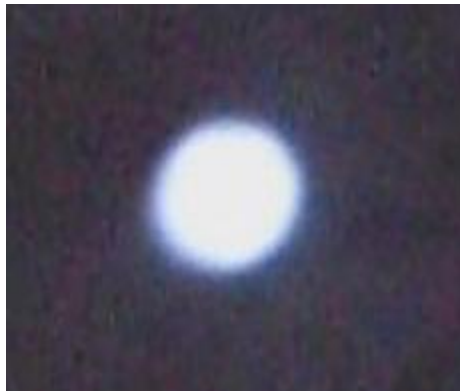
Figure 16. Returned image from the spin-cast mirror. Some astigmatism is apparent. Mainly, the individual LEDs are not visible presumably due to the high-frequency ripple. The resolution is about 3 to 5 arc minutes.
