# Peacock Labs Mirror Coating Testing and Analysis

M. D. Holenstein

Gravic, Inc.

August 18, 2010

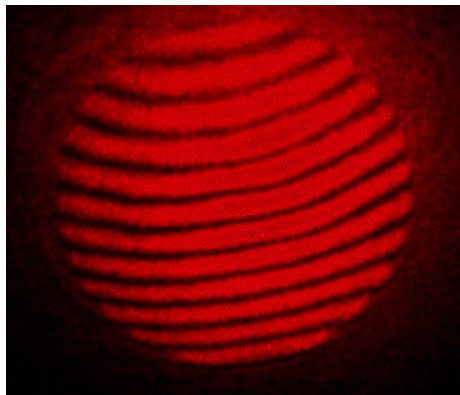
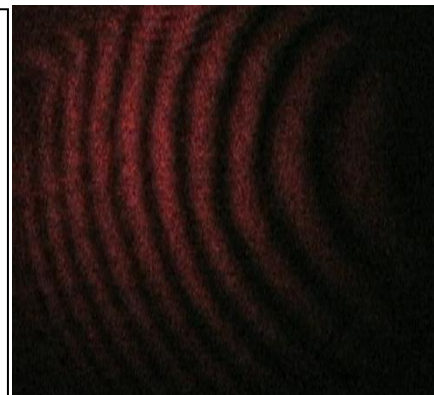
## Typical Interferogram

These interferograms were taken off the same mirror surface. The image on the right was for an uncoated mirror. The left was taken after the Peacock Labs silvering process was applied.

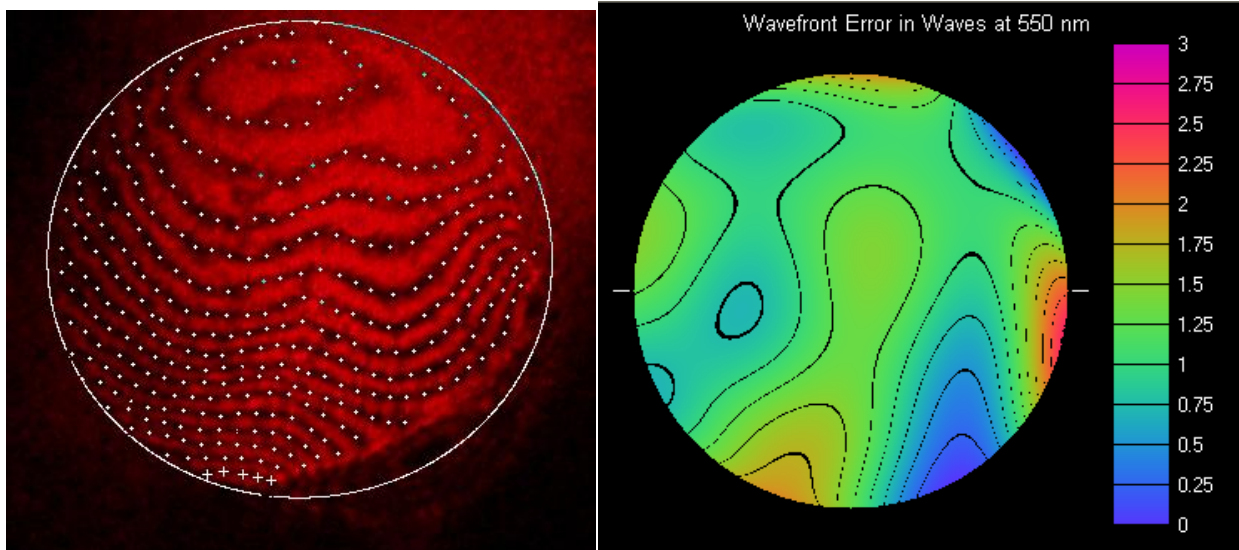
Silvered and thin Permalac

2 thin Permalac coatings- The surfaces are mostly uniform with a yellow tinge color. The coating seems to have run slightly during the drying process.
